Here Is What a Hydrogen Embrittlement Failure Really Looks Like

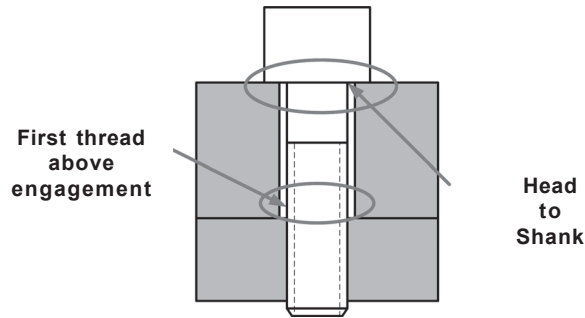
The picture of the broken zinc plated socket head cap screw in this article is a great example of what a typical hydrogen embrittlement failure looks like. I thought this would be a good example to share with readers because the discussion of hydrogen embrittlement comes up so often, but most people in industry do not know what a real hydrogen embrittlement failure looks like.

4. The appearance must be that of an "intergranular" failure. Look closely at the surface of the broken areas in the photograph in this article. The surface of the failure looks relatively smooth with a texture that looks like the surface of emery cloth. If you look at it under magnification, you see that the surface has a crystalline appearance with many sharp faces or facets. Some describe the appearance as being similar to broken rock candy.

In the case of head to shank failures, it frequently looks like someone used an ice cream scooper to scoop the shank out of the underside of the heads, as is the case in the pictured part.

1. Do not electro-plate inch socket head cap screws, L-9 bolts, or metric property class 12.9 bolts or screws.

2. If customers insist on using electro-plated bolts and screws, suggest they consider using a Grade 8 or property class 10.9 part of a slightly larger diameter instead of using the socket head cap screw or property class 12.9 part.

3. If the customer insists on using an electro-plated socket head cap screw or property class 12.9 part, specify that the parts must be baked at 375-400 degrees F within one hour after plating for at least four hours "at temperature."

Also, conduct one of the recognized hydrogen embrittlement tests on every lot of parts to provide you the opportunity to catch hydrogen embrittlement before it is exhibited in the user's application.
