# Here Is What a Hydrogen Embrittlement Failure Really Looks Like

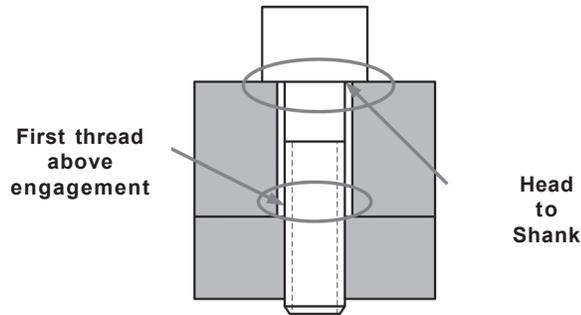
**T**he picture of the broken zinc plated socket head cap screw in this article is a great example of what a typical hydrogen embrittlement failure looks like. I thought this would be a good example to share with readers because the discussion of hydrogen embrittlement comes up so often, but most people in industry do not know what a real hydrogen embrittlement failure looks like.

4. The appearance must be that of an "intergranular" failure. Look closely at the surface of the broken areas in the photograph in this article. The surface of the failure looks relatively smooth with a texture that looks like the surface of emery cloth. If you look at it under magnification, you see that the surface has a crystalline appearance with many sharp faces or facets. Some describe the appearance as being similar to broken rock candy.

In the case of head to shank failures, it frequently looks like someone used an ice cream scooper to scoop the shank out of the underside of the heads, as is the case in the pictured part.

3. If the customer insists on using an electro-plated socket head cap screw or property class 12.9 part, specify that the parts must be baked at 375-400 degrees F within one hour after plating for at least four hours "at temperature."
